ORIGINAL CONTAINS COLOR PLATES: ALL DDC  
REPRODUCTIONS WILL BE IN BLACK AND WHITE  
SUGAR RUN DAM

(NDS ID Number 464)

PHASE I INSPECTION REPORT

PHASE I REPORT  
NATIONAL DAM INSPECTION PROGRAM

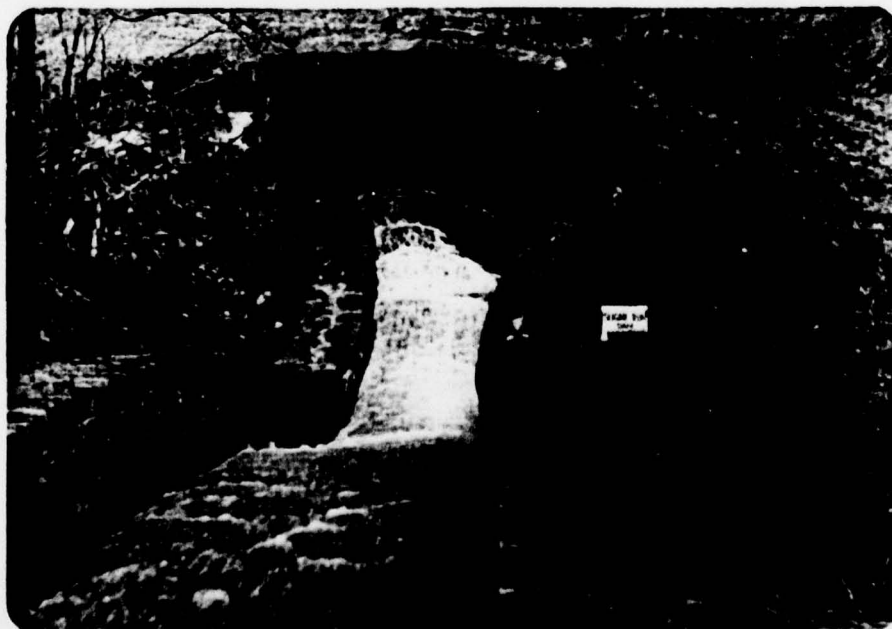
Photograph No. 4  
Plunge pool.

The plunge pool was examined and no major scouring or erosion was observed (Photograph 4).

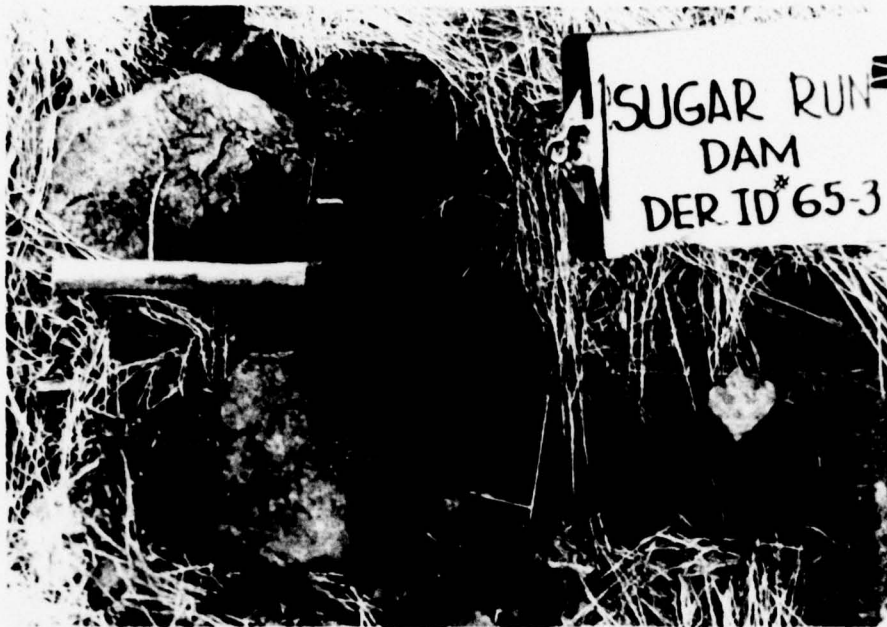
Photograph No. 7  
Moist area on embankment (see Plate 3).

2. At midheight of the embankment, the downstream face was observed to be moist (an indication of the phreatic surface intercepting the downstream slope).
3. An area approximately 10 feet high by 50 feet long at about midheight of the downstream slope was measured to have a slope of approximately 1.5 to 1, which is steeper than the design slope of 2 to 1. Various other slope irregularities and bulges were also noted. Those irregularities correspond to the elevation of the wet conditions observed on the embankment slopes.
4. Riprap on the crest and the downstream face was observed to have weathered substantially, but the extent of riprap weathering is not considered to be significant. No erosion problems were observed.

The presence of moist areas and various slope irregularities on the downstream slope also suggest possible instability of the embankment due to a high phreatic surface through the embankment.

1. The stability of the dam should be evaluated further in view of the following conditions:  
(a) the presence of slope irregularities and wet areas on the downstream slope, and (b) numerous seeps at the toe level containing "yellow boy."
2. Since the adequacy of the concrete casing around the pipes through the embankment could not be reliably assessed, the owner should evaluate the structural integrity of the pipes and the casing and investigate the need for placing upstream controls on these pipes.
3. The owner be advised to repair the sharp-crested weir which was constructed to measure the seepage from the dam and keep seepage records to aid in further investigation and future evaluations of the dam.

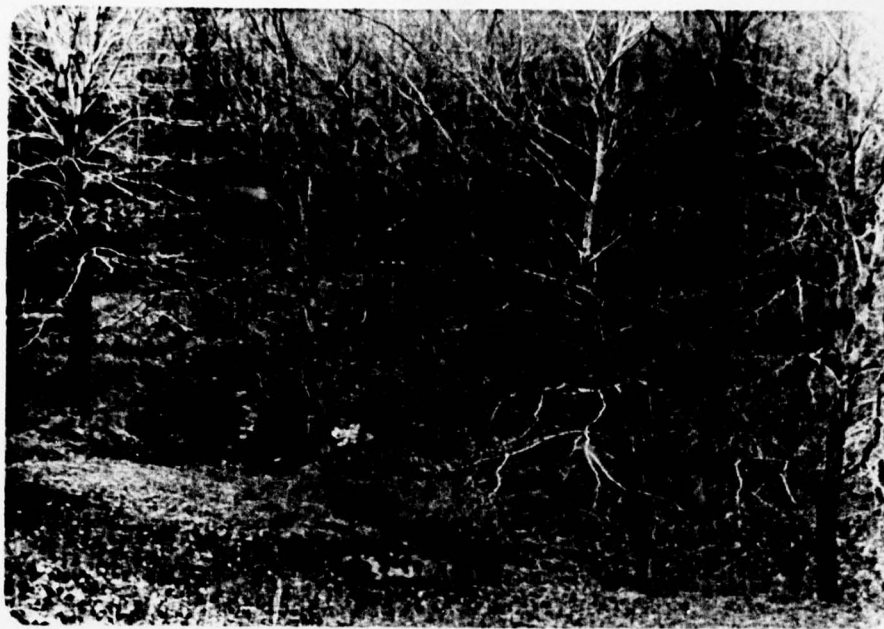
Photograph No. 11

1. Most of the downstream toe area was wet and swampy (Photographs 9, 10, and 11). Two main seepage areas were observed. One was located to the left of the center of the embankment and was being fed by water discharging directly from the toe of the dam (Photograph 11) and by discharge from two 4-inch pipes whose source is not known. The second seepage area was to the right of the center line of the dam and was being fed by a swampy area near the toe. Both seeps were collected in a single channel and discharged through a sharp-crested weir into the stream. The weir was not functional at the time of inspection. Total seepage flow at the weir was estimated to be 15 to 20 gallons per minute. The

seeps were clear; no indication of boiling was observed. However, all seepage areas were saturated with ferric-hydroxide (yellow boy).

Seepage at the toe (to the left of center, see Plate 3).
